Marathon Manufacturing

Case Background on the GOTAHAV Aircraft

Statement on Behalf of Marathon Manufacturing

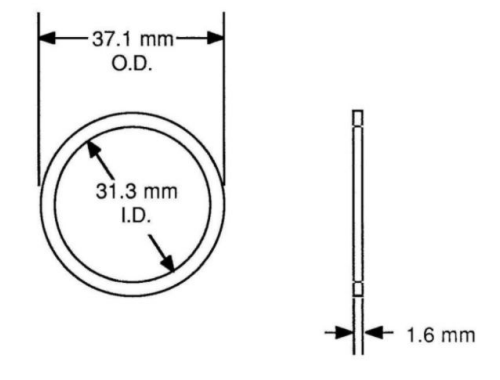
1. Cut to length require for several pieces
2. Turn O.D.
3. Bore out I.D.
4. Cut piece to length
5. Grind sides, I.D., O.D. to size
6. Polish all surfaces

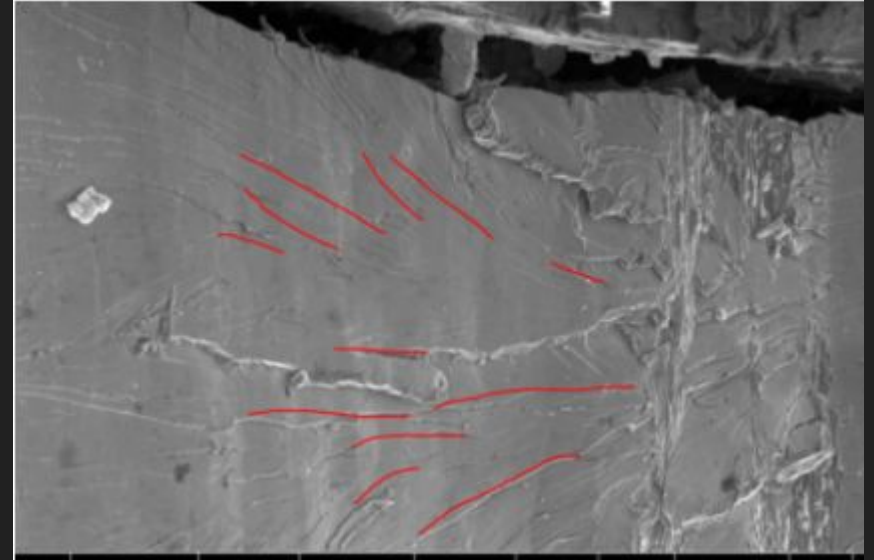
Feather Pattern

Failure site of the seal ring

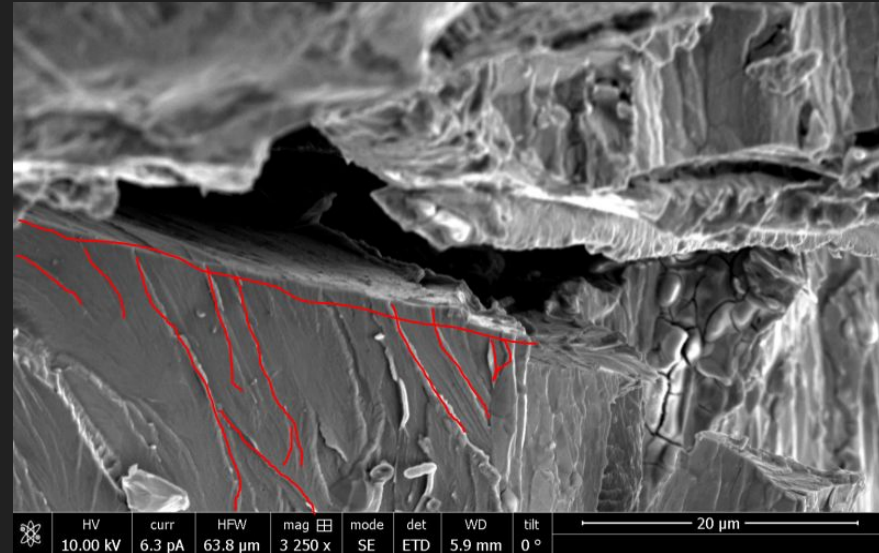
River pattern

Failure site of the seal ring

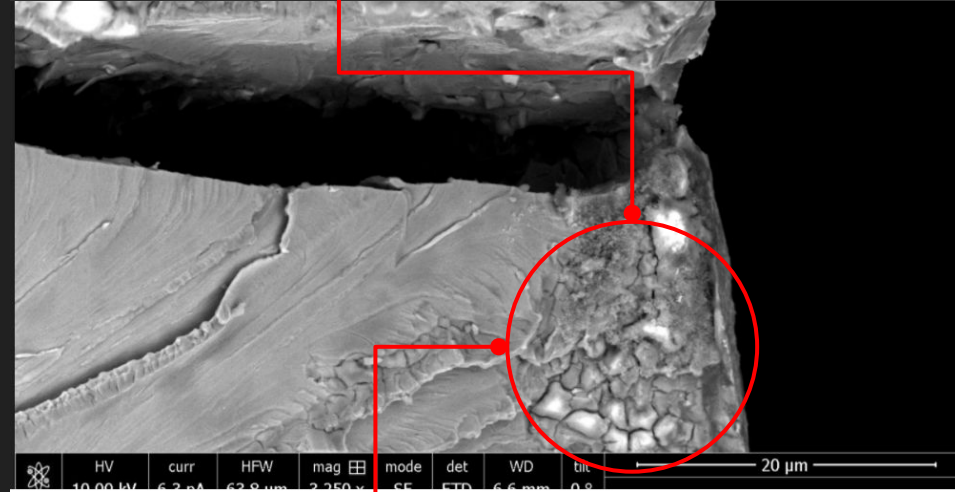
**High Temperature
Rupture**

**Melted Grain
Boundaries**

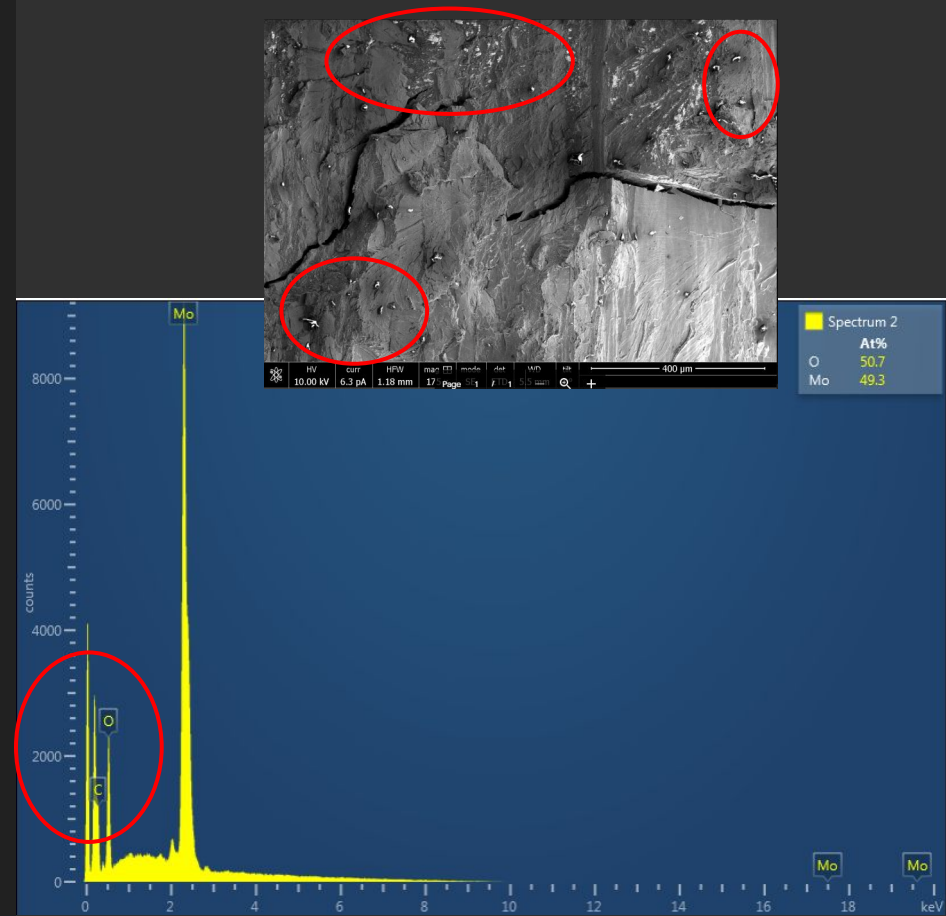
EDS Evidence

It has long been recognized that oxygen can severely embrittle Mo by segregation to grain boundaries.²⁵ The recent work by Kumar and Eyre,³ briefly discussed earlier, has emphasized this point. In their work, it was shown that carbon is effective in reducing the driving force for oxygen
